# THE PRESSURE IS ON!

Phil Auldridge  
1953 Ariel Square 4 Mk II

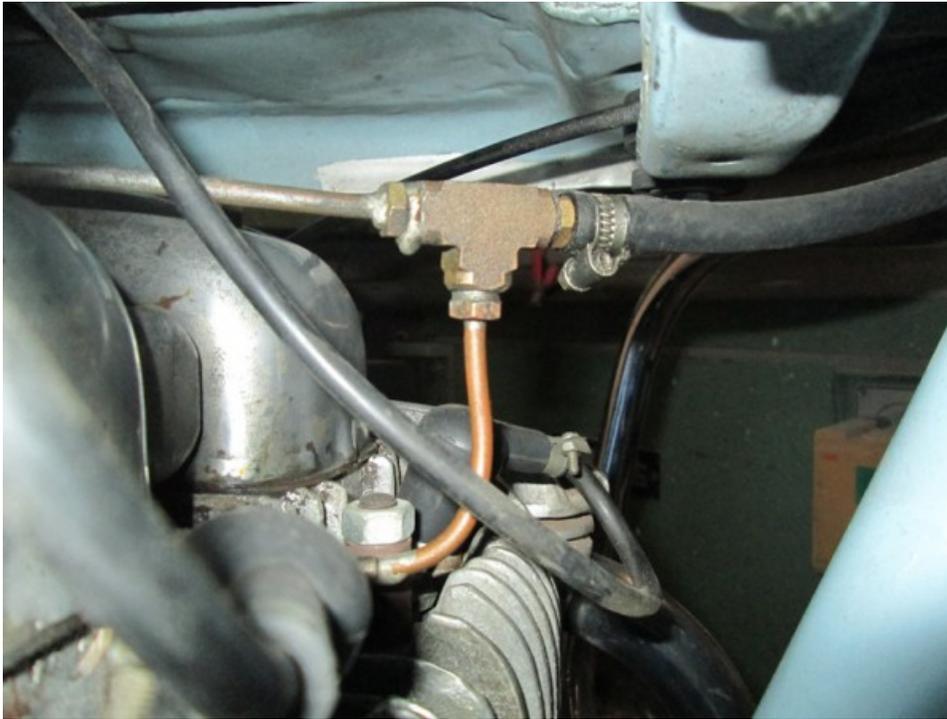
Aftermarket external oil gauges for British bikes typically rely on connection to the banjo bolt fittings at the rocker arm feed lines, usually at the point they attach to the head. Unfortunately, the flared/nut fittings on the Ariel external lines don't readily lend themselves to an external connection. I have seen some of the most gawdawful home made solutions for our bikes.. clumsily soldered "T" connections accompanied by a variety of fittings from the plumbing department of Home Depot. All of these solutions appear dubious at best, and interfere with the clean lines of the engine. Here is one

example (not recommended!)

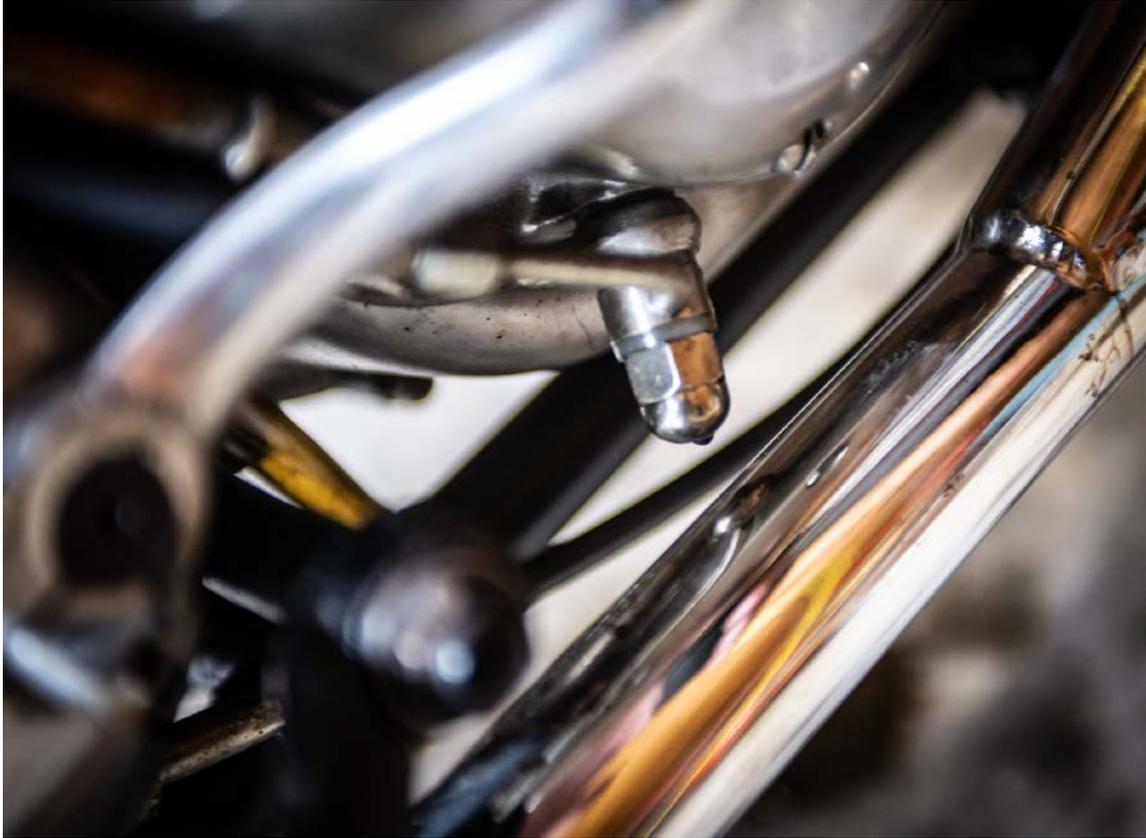
His solution is very elegant: He machines a special, extended length hollow oil feed stud to replace the original stud located at the aft, lower timing side of the crankcase, the fitting that feeds the external rocker oil supply line. This extended length stud allows the stacking of the original banjo fitting from the stock supply line along with his provided second banjo fitting which connects to the oil pressure gauge line. Here is what the completed installation at the crankcase looks like.. out of sight, out of mind:

I found ample clearance room to remove the old stud (a high quality stud remover socket is recommended) and replace with the new longer one. You can see the provided nylon sealing washers that go between the two banjo fittings and the crankcase, which have proven to be completely leak free.

The new gauge fitting attaches to a provided small-diameter nylon line, attaching at both ends (including at the gauge) via tiny compression fittings, again proving themselves to be completely leak free.

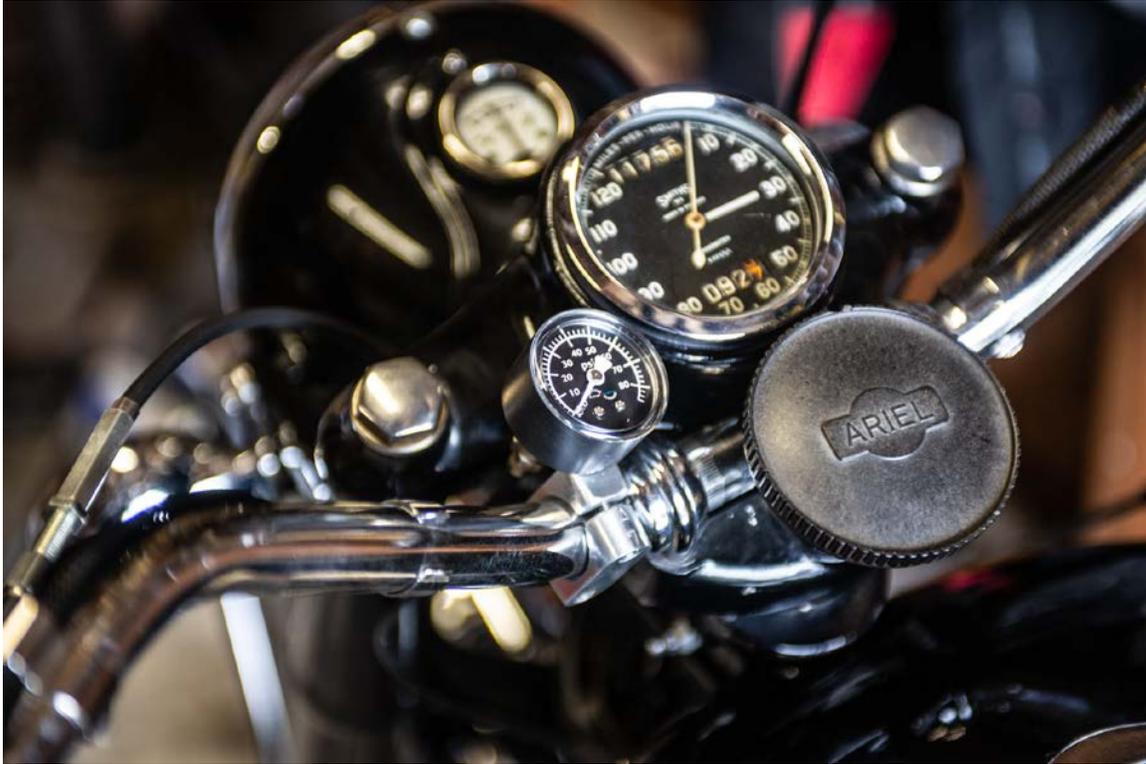
Finally, the kit is completed with a polished billet aluminum handlebar clamp, along with a small-face gauge that could very easily have been original equipment on this bike.

I couldn't be happier with the finished results, and with the added peace of mind from knowing I am able to constantly monitor my oil pressure while riding.
